FUEL

Forward Engineer Support Team bringing fuel distribution system back to life at former Iraqi airbase

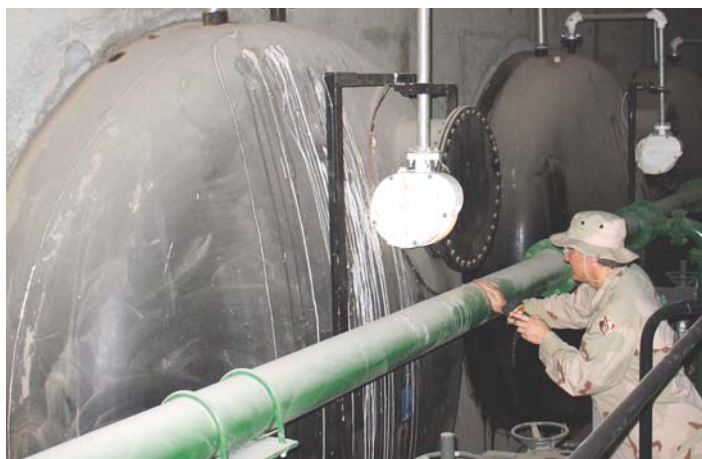
Tammie Stouter, with the Combined Joint Task Force-7 Forward Engineer Support Team Augmentation, looks at a gauge inside a fuel bunker on the former Iraqi airbase.

Improvements to the life safety aspects of the fuel bunkers are part of the plan, she said. "We're having them install a fire suppression system. There is one here, but we are not sure it is a viable system."

Additionally, the ventilation and exhaust systems will be tested and upgraded, if necessary, to meet current Stateside standards. "In some areas there were no pumps to circulate fresh air, just vents, so that's something we really have to address," she said.

Some wiring of the electronically monitored, gauged, and switched systems has been looted, but wiring diagrams are still on hand to make their repair easier, Stouter said.

Once the repair project is awarded to go through each of the systems, replace any missing parts and check for leaks, work is anticipated to be completed within six months, Stouter said. The contract also will call for the assessment of the Al Asad bulk storage and bunkers there for possible repair under a separate contract.

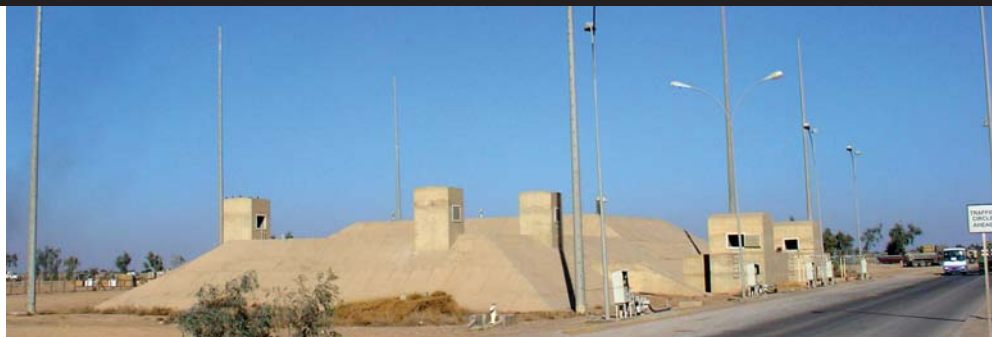
The fuel bunkers are essentially fuel storage and filtration systems housed in bomb resistant shelters. Each bunker provided fuel to a set of four large concrete aircraft hangers linked by short taxiways to the runway. The fuel bunker systems were designed to feed fuel directly inside the hangers, allowing fighter aircraft to be refueled from hydrants using hoses and pump carts that would be brought inside the shelters. U.S. Army aviation, however, does not follow the practice of refueling inside enclosed spaces for safety reasons, Lamb said.

The large fuel bunkers are most readily distinguished from concrete hangars and aircraft and equipment revetments by the presence of multiple

Fuel bunkers on the former Iraqi airbase are being brought back to use.

lightning rods.
